### uSense

### Case study #1 - Renaissance Parade Shield

## Applicative Note - Cultural Heritage and Art Conservation

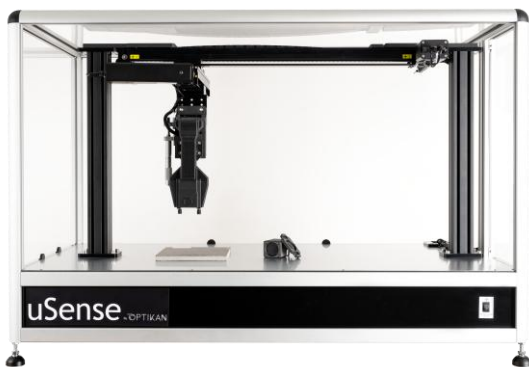
uSense is an all-in-one raster-scan millimeter 3D imaging system designed specifically for scientific applications. It offers unique features and remarkable performance, enabling volumetric control of the structural integrity of any dielectric object.

Highly versatile, uSense can be adapted to numerous studies: detection of cracks, delamination, metallic or wet foreign bodies, extraction of permittivity, optical indices, and even provide density information.

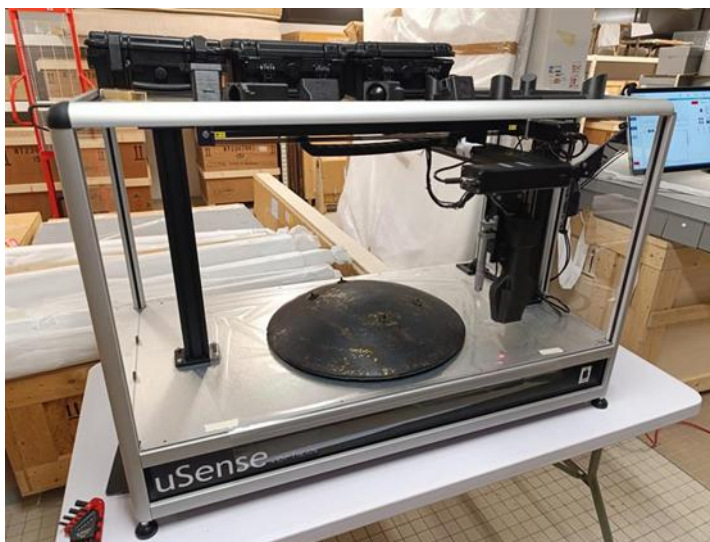
Figure - Parade Shield in the uSense station

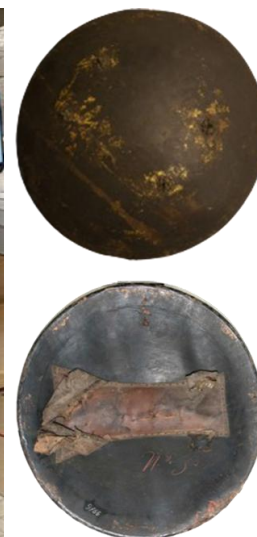
Figure - Top and Bottom View

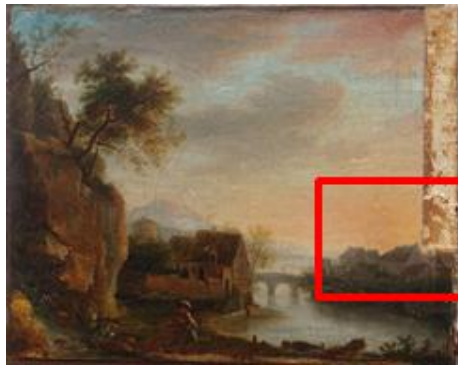
Figure - Painting

From acquisitions performed on limited regions of interest, the system demonstrated its ability to discriminate successive internal layers in depth that are not visible in conventional optical images restricted to surface information. These internal strata appear as distinct interfaces within the canvas assembly, revealing a layered structure that cannot be inferred from visual inspection alone.

For this painting, the 60 GHz configuration was not used, as the limited thickness and planar geometry of the canvas did not justify the use of lower frequencies with reduced spatial resolution. The analysis therefore focused on higher millimetric frequencies, which are better suited for resolving fine stratigraphic features within thin layered structures.

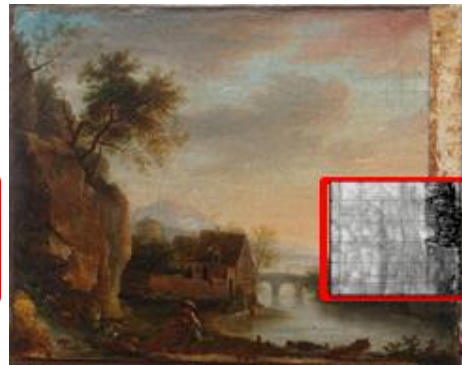
Figure - 240 GHz Image on ROI

The presence of such stratification constitutes a potential indicator of a relining or re-adhering operation, as additional adhesive or interface layers are typically introduced during such conservation treatments. While millimetric imaging alone does not allow definitive material identification, the observed layered structure provides structural evidence that may support conservation hypotheses when interpreted alongside historical documentation and complementary diagnostic techniques.

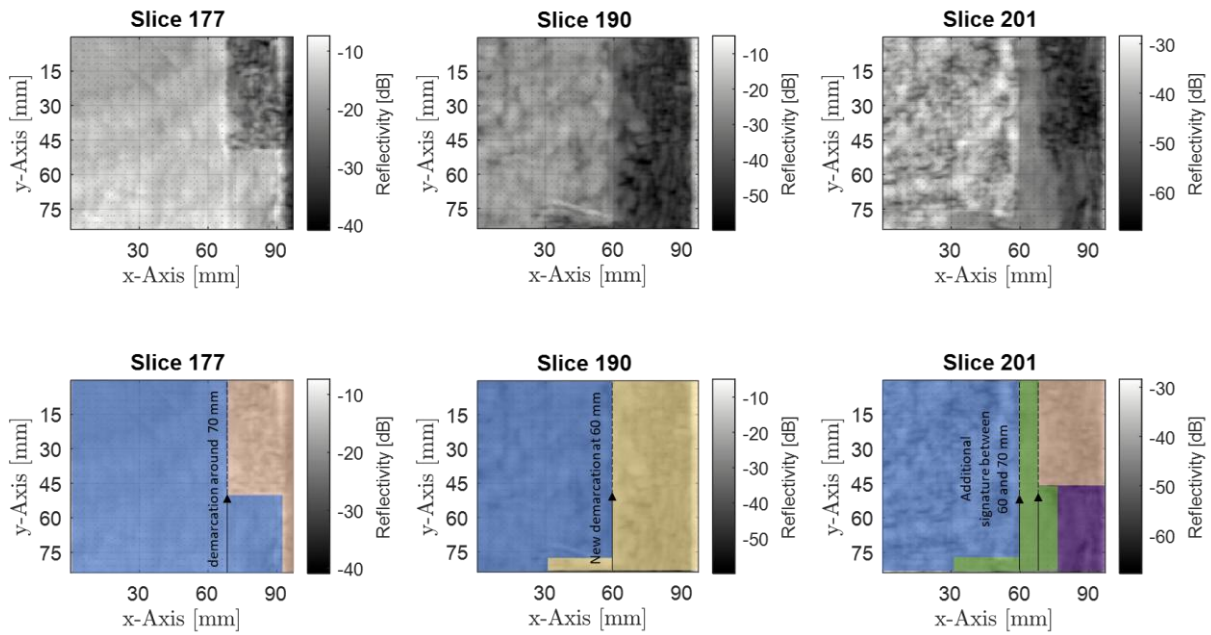
Figure – Stratification Highlights

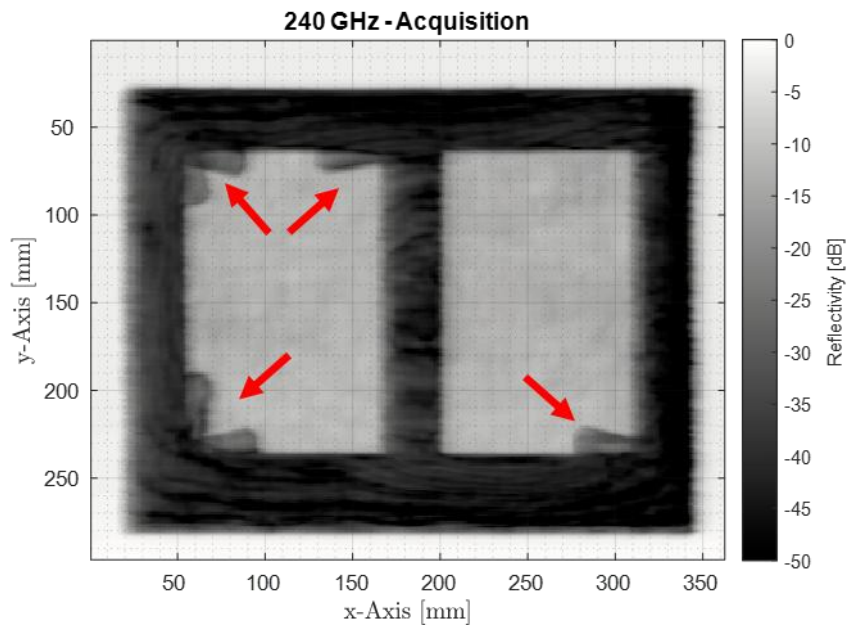
Extended acquisitions performed over the entire canvas revealed localized demarcations with increased absorption, particularly in areas where the original wooden frame is no longer present but remains in close proximity to former contact zones. These features indicate localized material or structural heterogeneities within the canvas assembly. While their exact nature cannot be unambiguously identified based on millimetric imaging alone, such demarcations may be consistent with residual adhesive layers or interface modifications associated with past conservation interventions.

Figure - Area with Increased Absorption

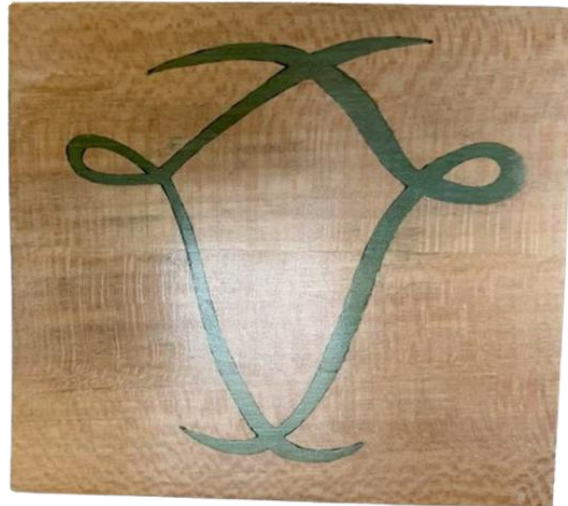
Figure - Wooden Marquetry

The third case study concerns a lacquered wooden marquetry object with a painted decorative design. Such artefacts are typically characterized by complex surface treatments and layered decorative finishes, which can significantly limit the penetration of electromagnetic waves and complicate internal inspection.

In this case, the primary objective was to assess whether millimetric imaging could provide insight into the internal construction of the wooden support, despite the presence of lacquer and painted surface layers.

Measurements were performed using several millimetric frequencies. Due to the strong attenuation introduced by the surface layers, no exploitable signal was obtained at the higher frequencies. Only the 60 GHz configuration provided sufficient penetration to probe the internal structure of the object. A focusing lens with a 50 mm focal length was used in order to maximize lateral resolution under these conditions.
